Task #1B- Column, Purlin and Truss Assessment,

Arena/Horse Barn Structural Evaluation

Department of the Interior
Bureau of Land Management
Eastern States
Meadowood SRMA
Lower Potomac Field Station

April 26, 2011

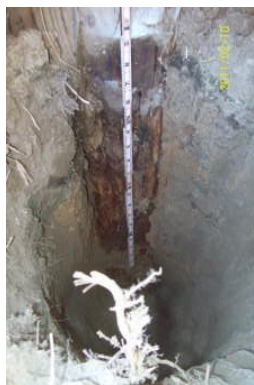
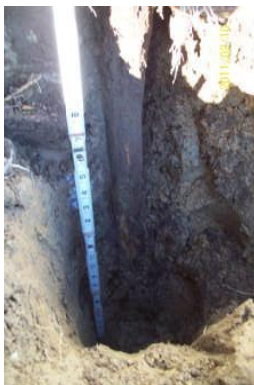
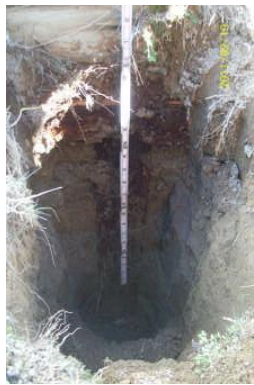
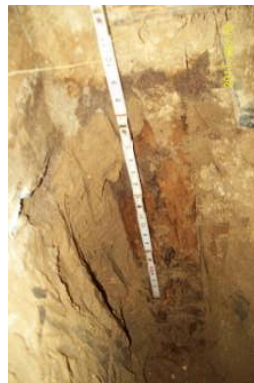
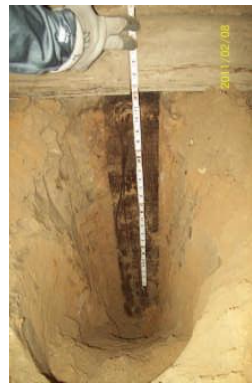
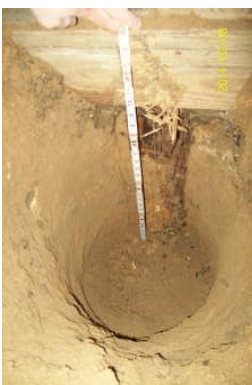
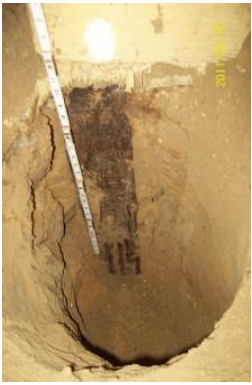
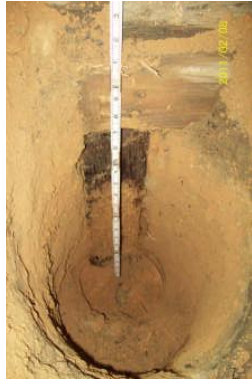
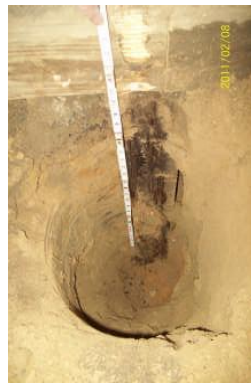
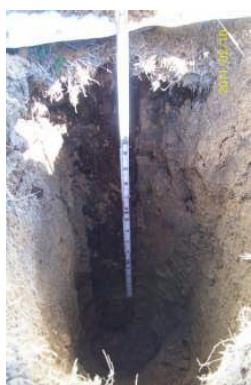
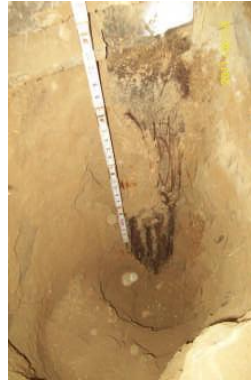
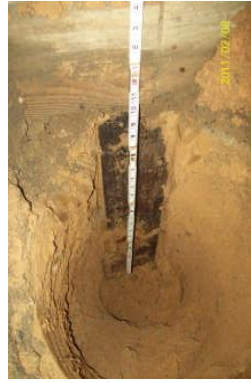
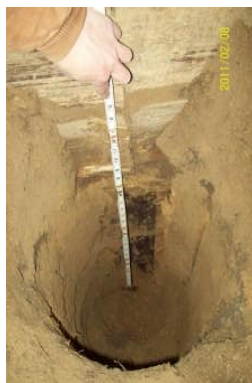
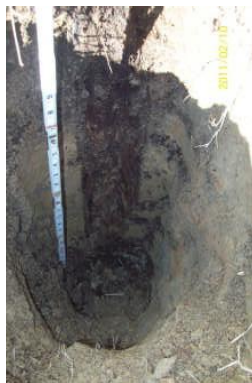
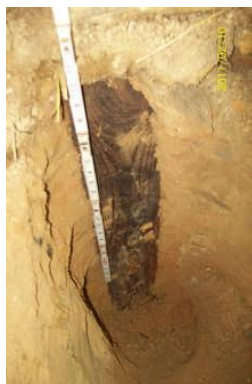
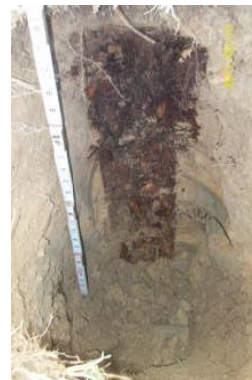
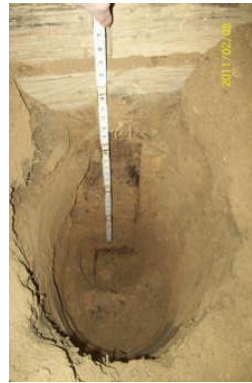
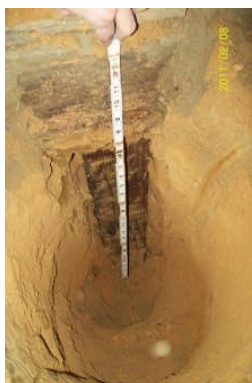
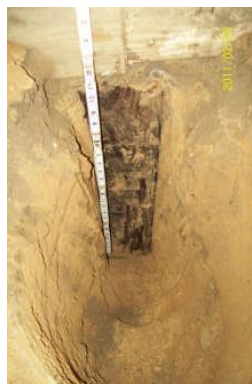
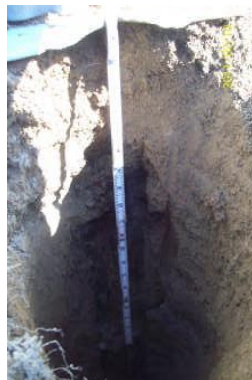
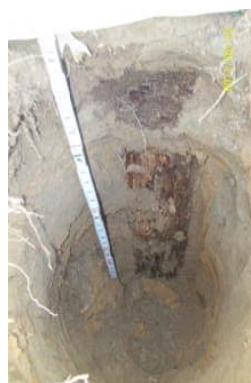
Figure #4 - Photographs of Columns below ground level.

2. **Columns** - The above grade structural condition of the columns is good. Unfortunately, for a structure of this type, the problems arise in the below grade state. An orderly sampling of columns were investigated using an earth auger to expose one face of the below grade portion. All columns had 30% moisture content in the wood at the below grade areas, which is excessive. According to the Southern Pine Association, marginal decay exist for moisture content ranging from 20-25%, Optimum decay exist for moisture content greater than 25%. The results of the moisture content are listed in Appendix A. The extent of the rot was not always visible, except in the eastern part of line G. Wood decays from the inside and permeates outward. The exterior may show no sign of decay but the sectional loss within can be considerable. The above grade moisture readings had typical moisture contents between 12-15%. However, there were a few isolated signs of above grade decay. Code requirements for a Type V building using column supports approves the use of pressure treated timber in accordance with American Wood Products Association (AWPA)U1 and Section 2303.1.8 of IBC 2006. However, no observations of pressure treated wood treatment were made nor annotated per Section 2303.1.8.1 of **IBC standards**. Typical construction techniques used at that time were to place the bottom portion (the anticipated length enclosed by soil) of the post in a vat of treatment material such as creosote and let stand for 24 hours.

2. Columns – The extended use of this building at the current IBC classification would require the exposure of the below surface portion of the columns to a depth of 24 inches to identify any decay or deterioration. Once exposed, the center of one face of the column should be drilled at 6" increments to determine if the interior of the column is competent. If decay is present the structure should be shored at this location, the full column removed or cut at projected concrete surface, and replaced in-kind with a new column or concrete. In addition, a field applied preservative should be used for all below grade portions of a new column. The process should then be repeated at the next column in line. Based on moisture readings taken at the site as a result of this investigation, it would be prudent to assume a minimum of 50% of the columns will require replacement. However, recommendations of this report would require further examination of the column bases by excavation to the bottom of the post to determine if column footings are present.

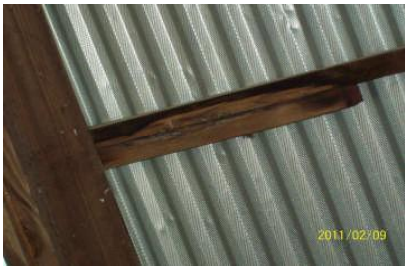
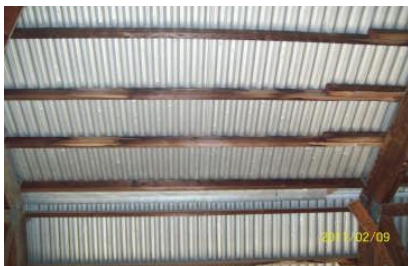
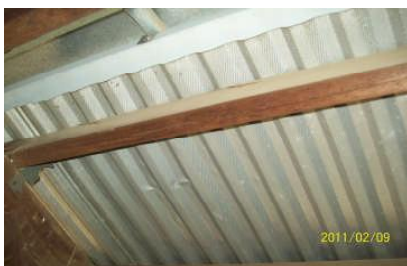
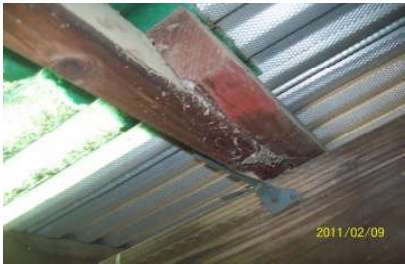
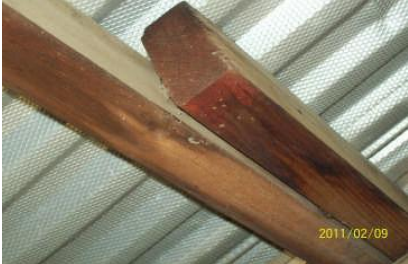
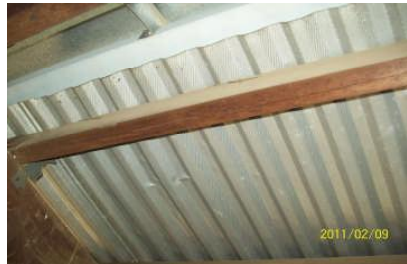
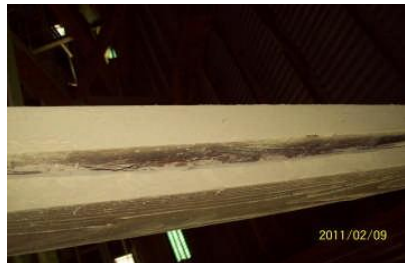
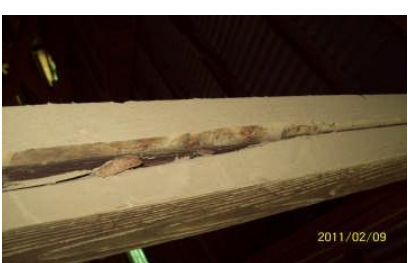
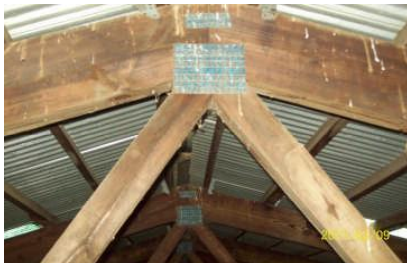
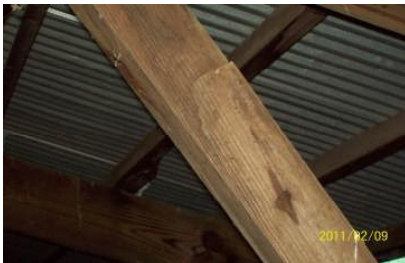
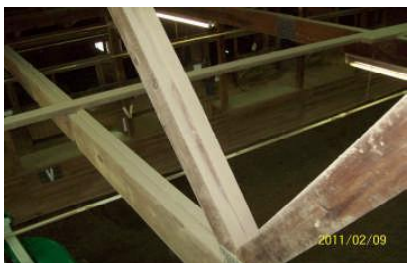
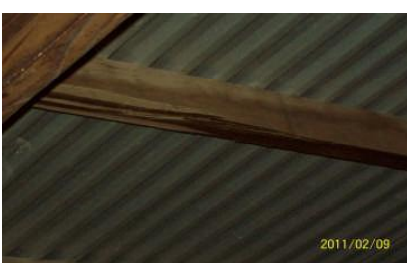
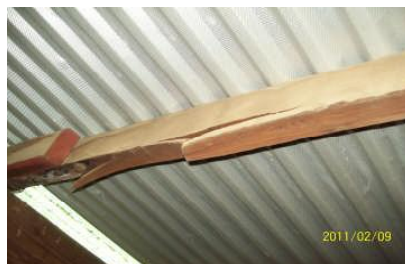
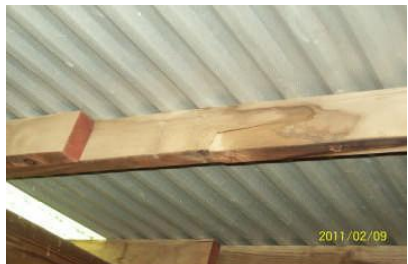
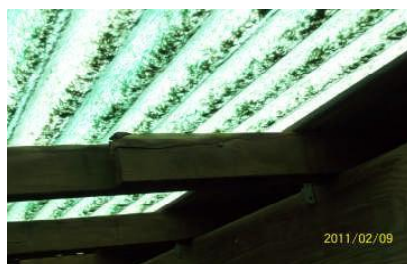
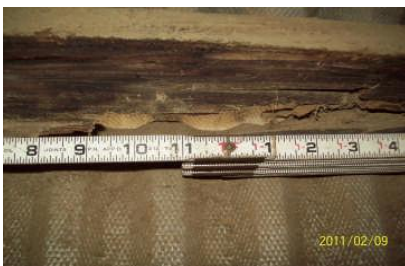
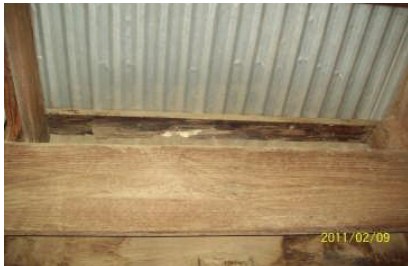
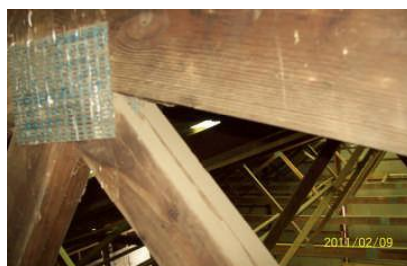
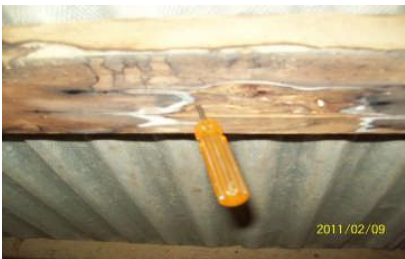
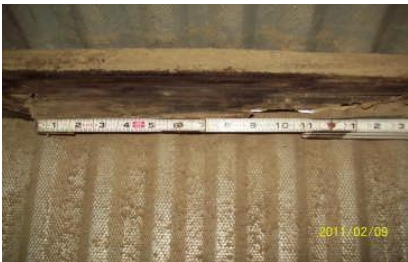
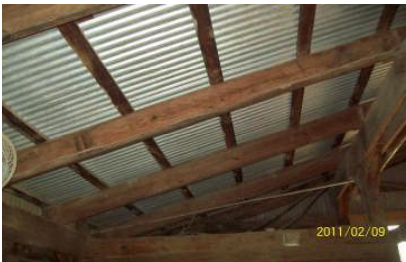
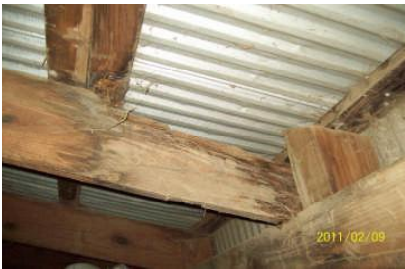
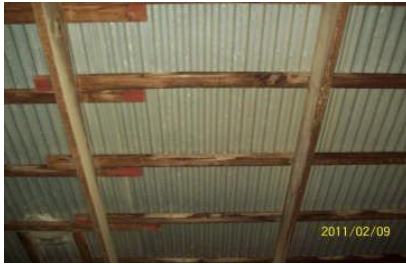
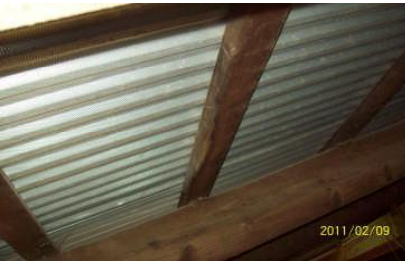
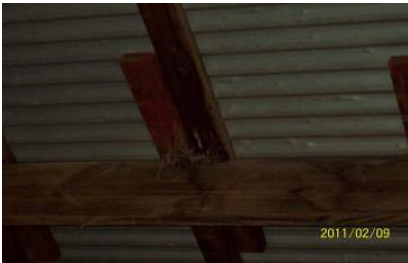
Figure #5 - Photographs of Purlins and Trusses

4. **Purlins** - The overall condition of the purlins in the truss area is average to poor with the upper most purlins ranked as the poorest. These purlins appear to have water damage and early signs of rot. Most rot is taking place at the connection point where the metal panel is connected to the purlins. This suggests the metal panel roof is leaking probably through the roof fasteners impacting the purlins at the panel-purlin connection. The overall condition of the purlins in the stall and aisle area is also poor with over half showing signs of rot. Moisture readings in Appendix A showed members to have content in excess of 20%. The 2x4 purlins that are present in the existing structure meets a Type V structure and consequently does not conform to a Type IV due to purlin size, which is nominally 4x6 lumber [4]. Therefore, this structure does not meet IBC 2006 requirements for upgrade.

Table #2 - Purlin and Truss Inspection from line A to G and 1 to 33 of the Barn.		
Arena		Note Book
Span	Description (use of a 2-man lift)	Page
2-3	Approximatley 10 purlins show staining and slight beginning of rot near overlap and apex (typical).	24
3-4	Approximatley 10 purlins stained from moisture on the surface and minor rot in overlap, one purlin split, 12.1-13.5% moisture in purlins and truss, roof sheeting well fastened.	24
5-6	Similar to 3-4, 2x4 web member (isolated) deteriorated from dry rot, nail in purlin chipped (isolated), bird nest in roof vent	24
9-10	Similar to 3-4, 12.1-13.5% moisture content in purlins and trusses, truss and web members split (photo taken).	24
10-11	Fourth purlin from apex split (3 feet long by 1/2 to 1/4 inch wide).	24
12-13	Two purlins split, one badly; periodic nailing missing maybe causing staining & slight rot.	24
16-17	Similar to 3-4; 12.1-13.5% moisture content; purlins simpson fasteners look good, no nails backed out; diagram in note book -typical purlin spacing is 2 feet with exception of 3 at 1'4" near apex; typical span of purlin is 8 feet from trusses.	25

19-20	Similar to typical	25
20-21	One purlin is rotted, complete section loss (see photo)	25
23-24	Similar to typical; isolated rot at end of purlin; splitting	26
25-26	Similar to typical; minor split in truss pieces	26
Stalls		Note Book
Span	Description	Page
2-3 East	Purlins at roof's edge severely rotted; nearly full section loss in one area; concerntated higher mositure are 19.1-20% and >30%; rafters in good shape 9.1-10% moisture content; typical spacing is 2 feet on-center with a 4-foot span.	27
5-6 East	Signs of rot; medium to servere on purlins; typical 3 purlins closest to outer wall is worst shape.	27
10-11East	6" to 10" medium to severe rot on first three purlins	28
25-26 East	Two feet and end of rafter severely rotted	28
31-33 East	Additional rafter added to supplement rotted exterior one.	28
Gen note	In stalls half of purlins show rot; should consider replacement especially outer purlins	28

3. Purlins – In the existing classification, all purlins should be replaced or reinforced. The in-situ conditions suggest water infiltration has been taking place for some time. Although the truss system is capable of meeting the design snow load, calculations in Appendix C show that the purlins in the truss area are not adequate. To remediate, these areas should be reinforced with new 2x4 purlins screwed to existing 2X4 purlins. Field inspection showed the existing purlins in the stall area have extensive deterioration, and over half of all purlins in the stall area have some degree of decay.
